**Overcoming geological challenges in the  
construction of a CFSGD diversion tunnel**

A.A. Mert, M. Salman and F. Çalışkan

*General Directorate of State Hydraulic Works, Dams and HEPP Department, Ankara, Turkey*

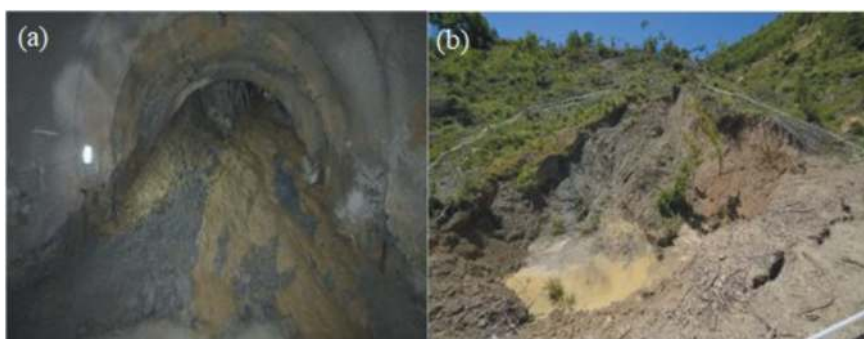
Tunnel excavation from the entrance portal proceeded to Sta. 0+162.00, but work was halted due to excessive spalling. Subsequently, a major collapse occurred around Sta. 0+164.00 within the graphite schist unit. This failure created a massive, chimney-shaped void measuring 8 meters in diameter and 19 meters in length, which extended upwards until it daylighted at the natural ground surface. The scale of this instability and its progression from the tunnel crown to the surface are documented in Figure 4.

Figure 4. Photos of the chimney-shaped collapse at the tunnel entrance (Sta. 0+164): (a) Internal view showing the failure of the primary lining and accumulation of debris; (b) External manifestation of the collapse on the natural slope surface, illustrating the upward propagation of the instability.

Following the collapse, an attempt was made to restart excavation using the Type 6A-2 support system, which included steel ribs with spiling. This intervention proved insufficient. The implemented spiles were inadequate in both length and thickness to withstand the ground load, causing them to bend and buckle. Due to the inability to safely stabilize the collapse zone, excavation at the tunnel entrance was suspended.

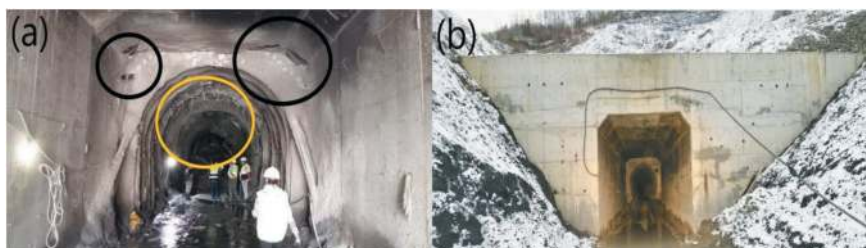
The geological structure at the outlet portal (clay, colluvium, and altered schist) was highly unstable. Local mass movements on the slope face, exacerbated by atmospheric exposure, threatened the portal. To mitigate this surface instability and allow for safe tunnel commencement, an approximately 20 m long cut-and-cover conduit structure was constructed at the tunnel exit.

Figure 5. Observed structural distress and the remedial measure: (a) Severe deformation of the primary lining with highlighted areas of crown distress and longitudinal cracking; (b) View of the stabilized structure following the 20 m extension of the conduit.

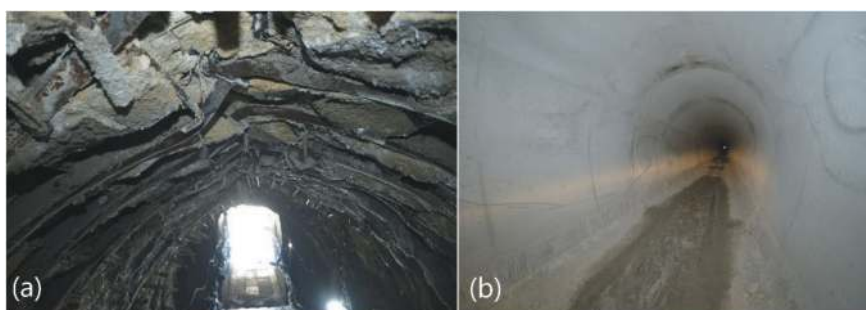
Despite the conduit and the upgraded Type 6A-1 support, excavation beyond the conduit (past Sta. 0+670) remained difficult. After advancing approximately 20 m, significant deformations were observed in the installed steel ribs, with movements of 2.5 cm measured over two days.

As instability worsened, ground stresses caused severe structural failures at the critical interface between the tunnel exit and the conduit. The concrete surface experienced ruptures spanning 100 cm, exposing the internal reinforcement bars and demonstrating the high magnitude of the ground load being transmitted to the structure. Figure 6 documents the resulting structural degradation, including the localized crushing of the lining and the failure of the steel support members.

Figure 6. View of the tunnel sections: (a) Close-up view of the structural collapse, showing twisted steel ribs and fractured shotcrete resulting from excessive ground pressure; (b) View of the final completed concrete lining, showing the stable condition achieved after overcoming the initial support failure.

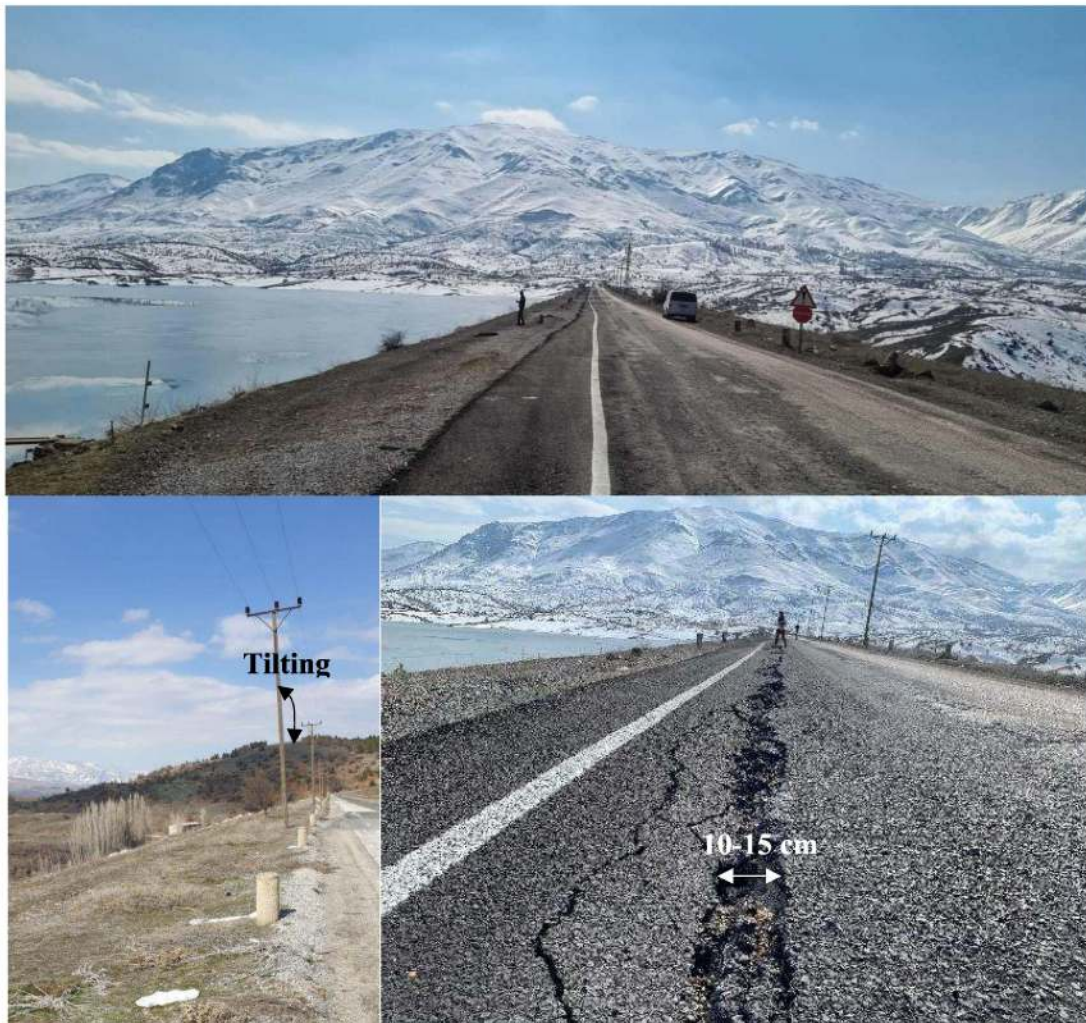
The photos taken during the site reconnaissance are shown in Fig. 2. Inspections revealed no visible cracking on the upstream and downstream slopes. However, the cracks with widths on the crest ranging from 10 to 25 cm were observed, with depths reaching up to 100 cm. The cracks along the crest were predominantly observed near the upstream section. On the other hand, longitudinal cracks shifted slightly towards the downstream side beyond the maximum section. Differential settlements of up to 5 cm were also observed, which is approximately 0.1% of the total height. This damage can be classified as minor according to Pells and Fell (2002), which aligns with the observations. Although the dam was subjected to high peak ground acceleration (*PGA*) at the site, it exhibited strong performance due to the lack of liquefiable soils on the foundation and the seismic resilience imparted by the prior retrofitting measures.

**Figure 2:** Photographs taken during post-earthquake inspections of Sürgü Dam, illustrating moderate levels of cracking along the crest.

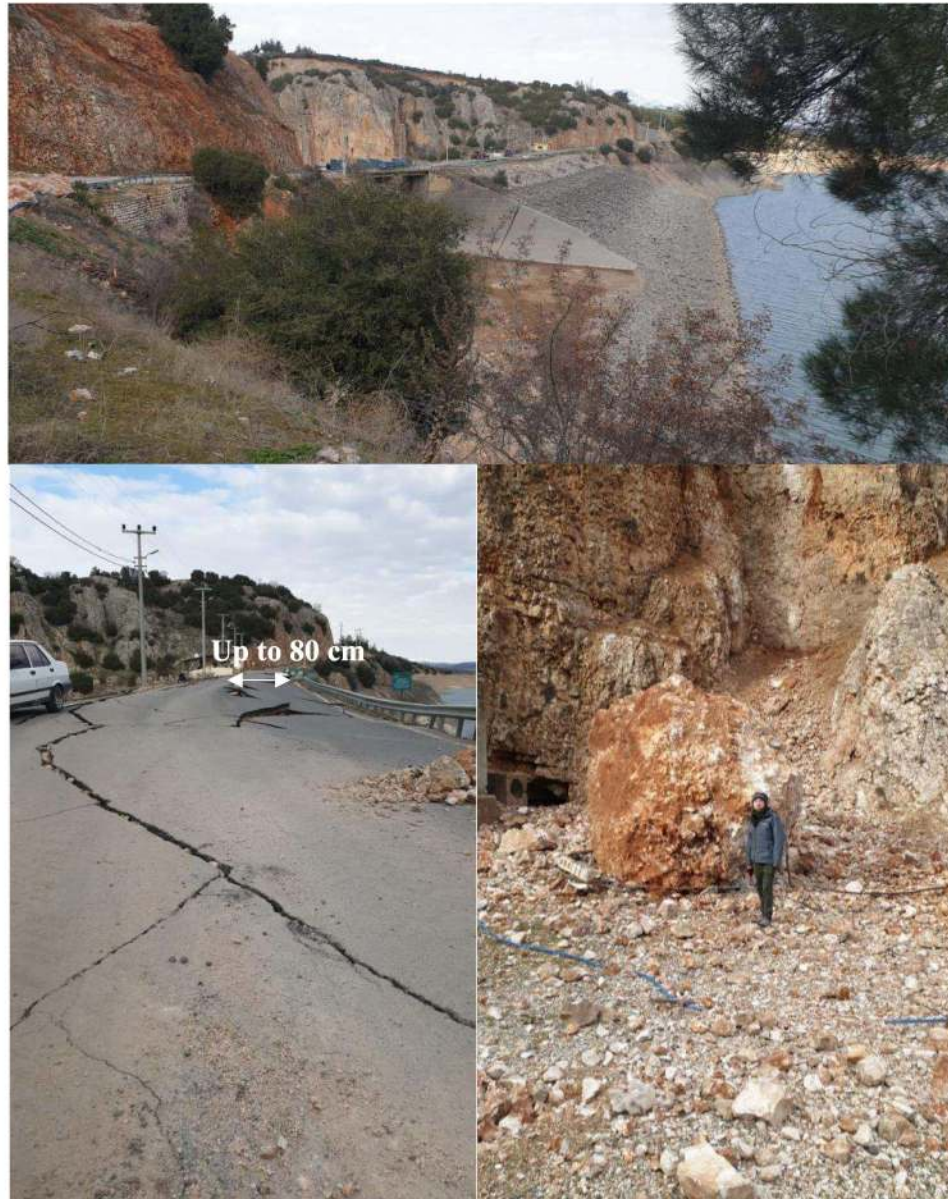
Fig. 3 shows photographs from a walk-down survey conducted on the dam, indicating no permanent deformations on the downstream and upstream slopes. On the other hand, longitudinal cracks and differential settlements along the crest were identified in the asphalt pavement on the crest road. The maximum width of permanent lateral movement was observed to be up to 80 cm at the center of the crest. Similarly, differential settlements of comparable magnitudes have been observed. This damage can be classified as moderate to major according to Pells and Fell (2002), which aligns with the observed conditions.

Upon examining the auxiliary structures of the dam, it was observed that only the wingwalls at the water inlet of the spillway experienced transverse cracking. However, this is not considered a significant concern in terms of operational status. Additionally, rockfalls have been encountered in many areas on site, further indicating the impact of seismic activity (see Fig. 3).

**Figure 3:** Photographs taken during post-earthquake inspections of Kartalkaya Dam, illustrating moderate to major levels of cracking along the crest.

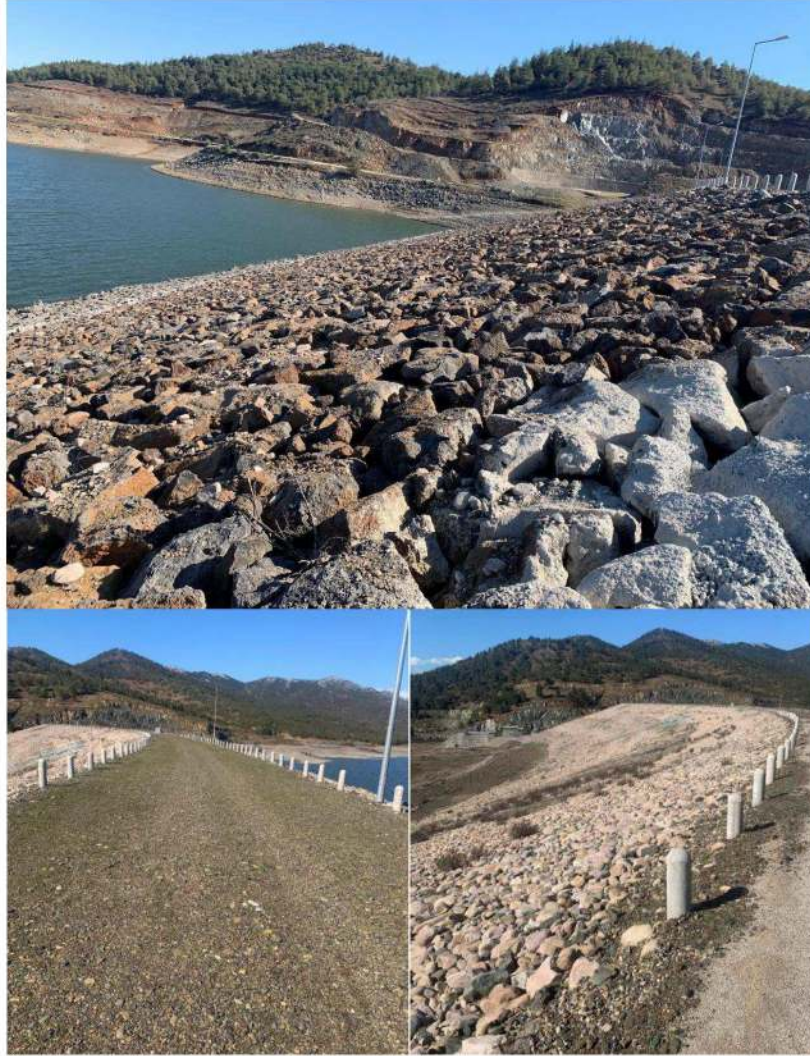
Fig. 4 displays photographs from a walk-down survey conducted on the dam, showing no permanent deformations on the crest, downstream, and upstream slopes. Also, it was observed that minor cracks on the order of millimeters occurred in the auxiliary structures as well.

**Figure 4:** Photographs taken during post-earthquake inspections of Tahtaköprü Dam, illustrating no or slight levels of cracking (DSI, 2023).

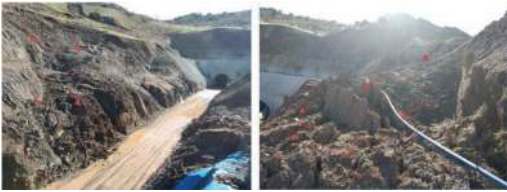
Figure 1. View of flows on the right and left slope slopes at the diversion tunnel entrance portal.

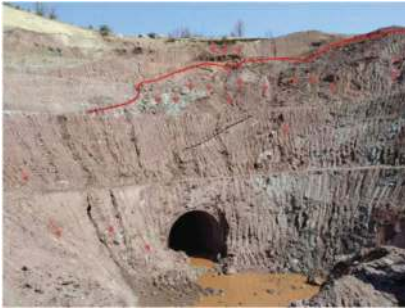
slope reinforcement in open excavations, there was an absence of support in the diversion tunnel exit excavations. These excavations, situated in an ophiolitic unit with weak to very weak rock slopes, remained exposed for an extended period without support, resulting in landslides and erosion triggered by water and rainwater. The diversion tunnel exit portal excavation, conducted in proximity to the body skirt, was observed to be opened without diverting the tunnel itself. This proximity to the body, and potentially within it, suggests a deviation from standard excavation practices. Furthermore, water inflows perpendicular to the diversion tunnel route were identified.

Figure 2. View of the diversion tunnel exit portal and slope failure.

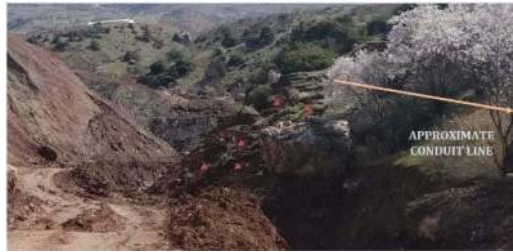
Figure 4. View from the slides on the hillside at diversion tunnel outlet conduit route.

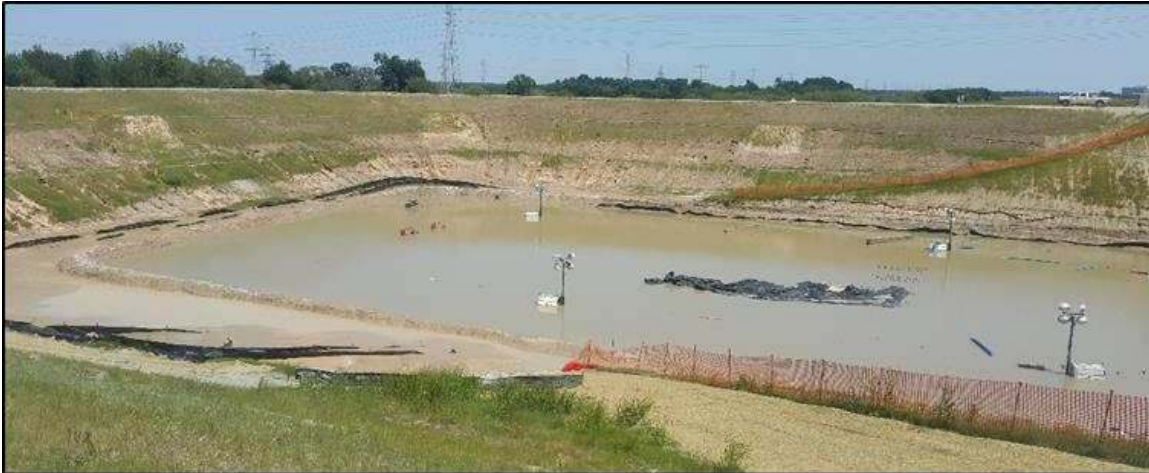
*Figure 7. Interior of Addicks construction cofferdam for new outlet structure, flooded from Buffalo Bayou backwater; note erosion channels on slopes (September 9, 2017, 29.79063° N, 95.62586° W).*

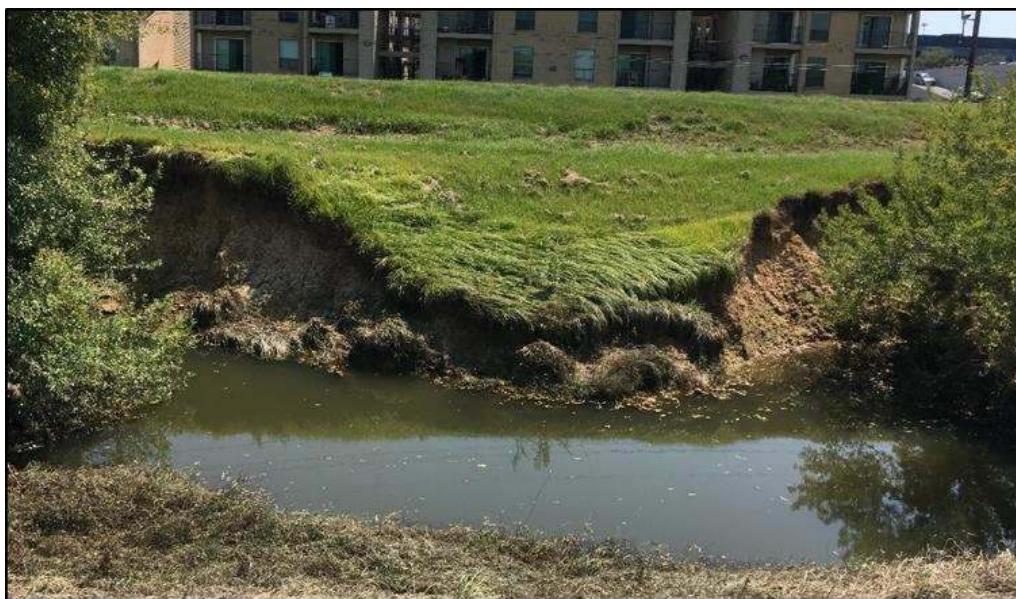
*Figure 12. Slope failures along Turkey Creek drainage ditch (September 9, 2017, 29.79009° N, 95.59639° W).*

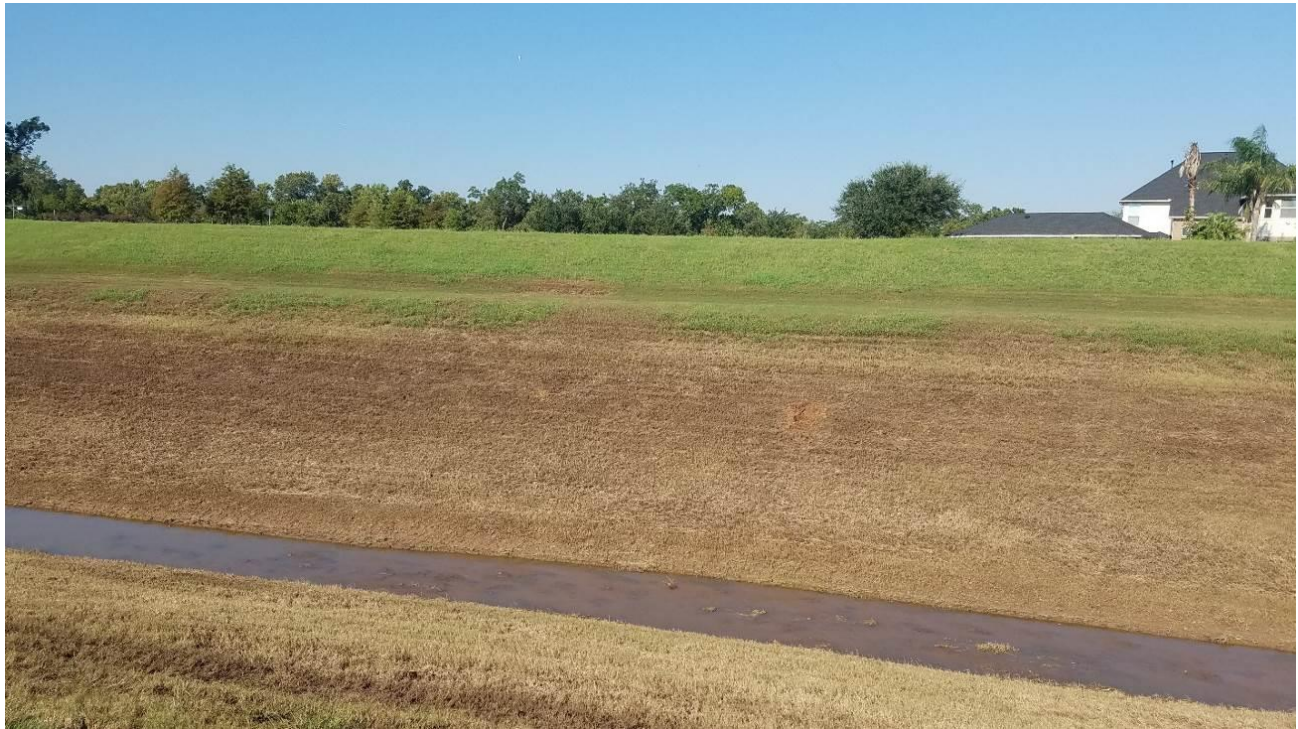
*Figure 16. FCLID2 drainage ditch to Brazos River facing FBLID14 levee. High water line and persistent water lines visible on FBLID14 levee (September 10, 2017, 29.55292° N, 95.61820° W).*

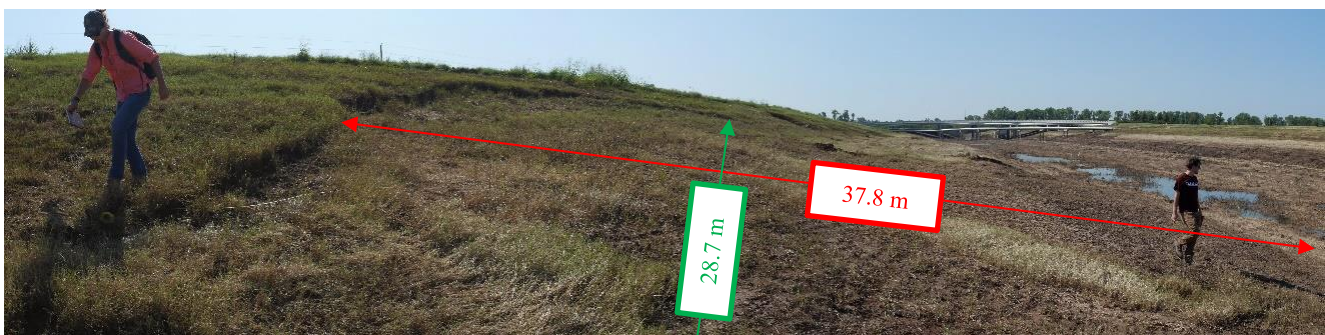
Figure 18. Ditch H levee, dimensioned slope failure (September 10, 2017, 29.55797°N, 95.63792°W).

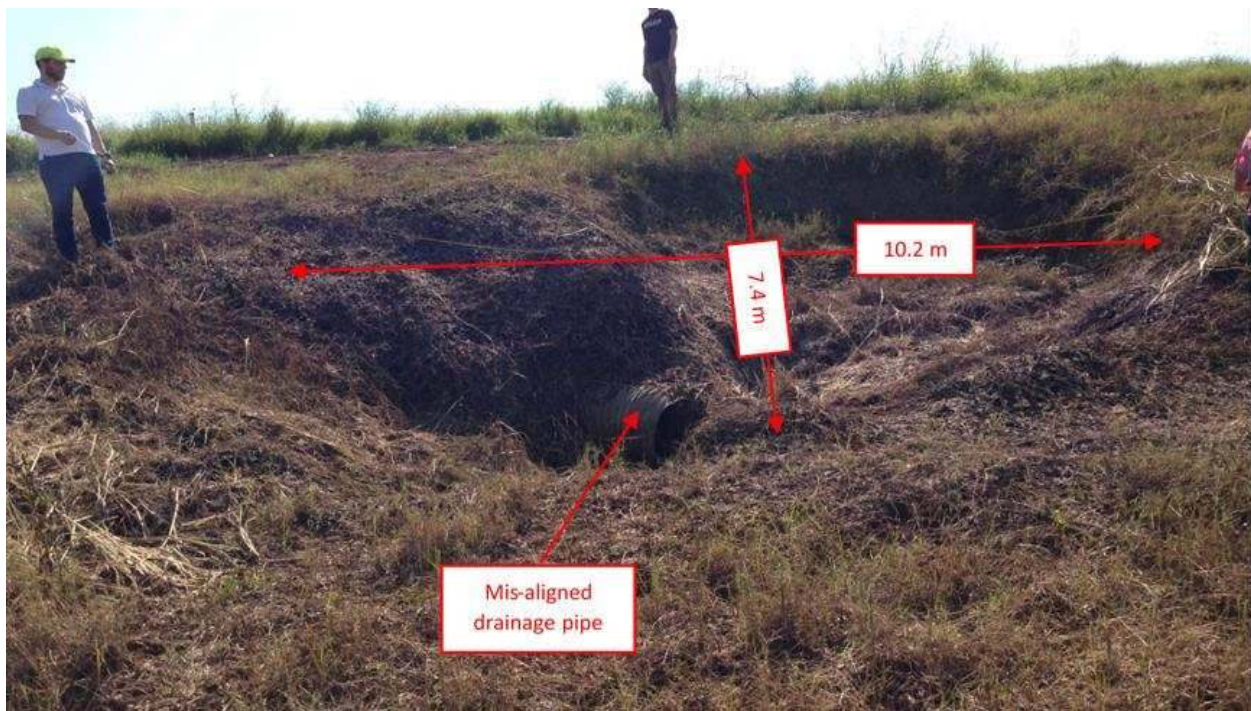
Figure 19. Sour hole at ruptured drainage pipe on Ditch H levee (September 10, 2017, 29.55759°N, 95.63768°W).

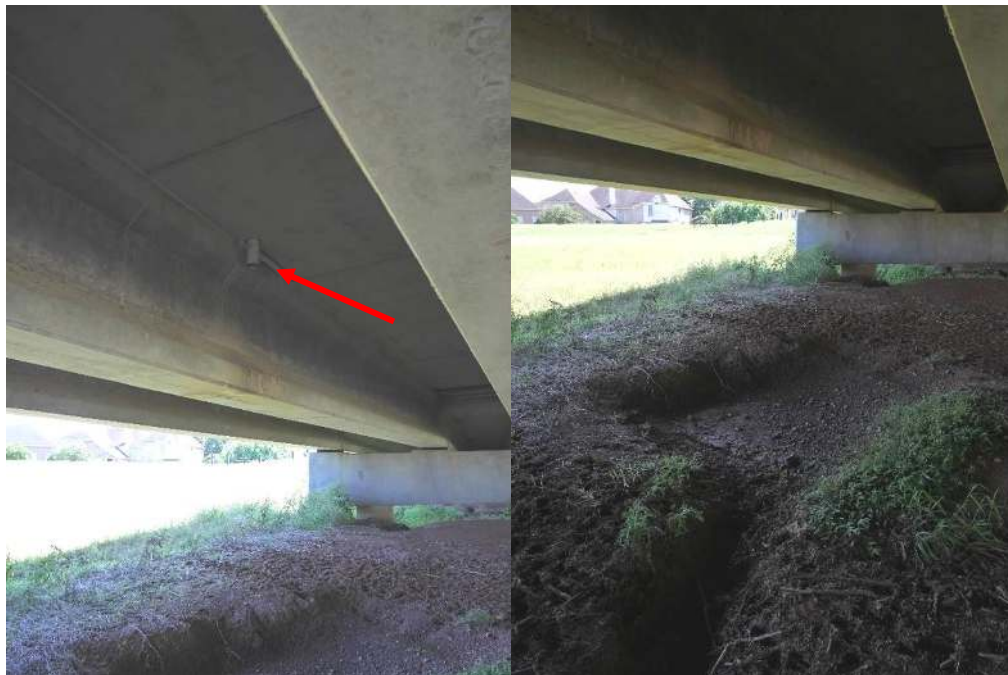
Figure 20. Erosion on Ditch H levee under the University Blvd Bridge due to flow impact from bridge drainage outfall (red arrow, September 10, 2017, 29.55902° N, 95.63744° W).

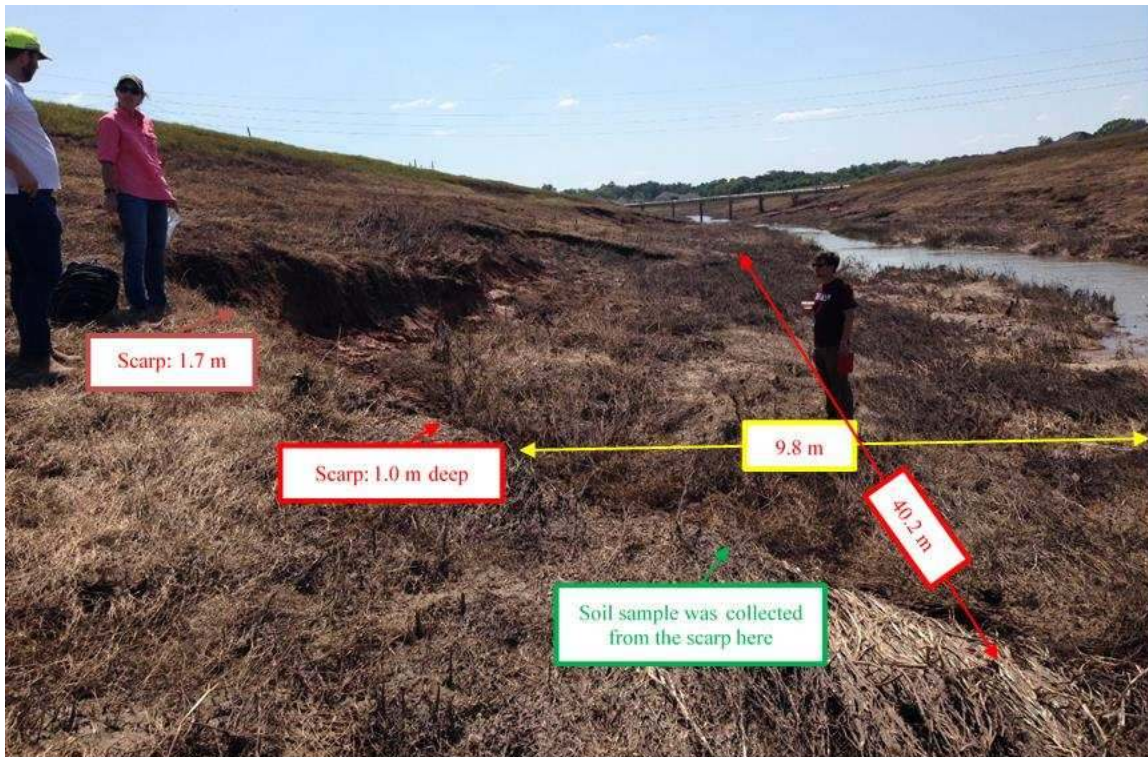
Figure 21. Slope failure north of damaged drainage pipe on the east side of ditch (September 10, 2017, 29.52647°N 95.56194°W),

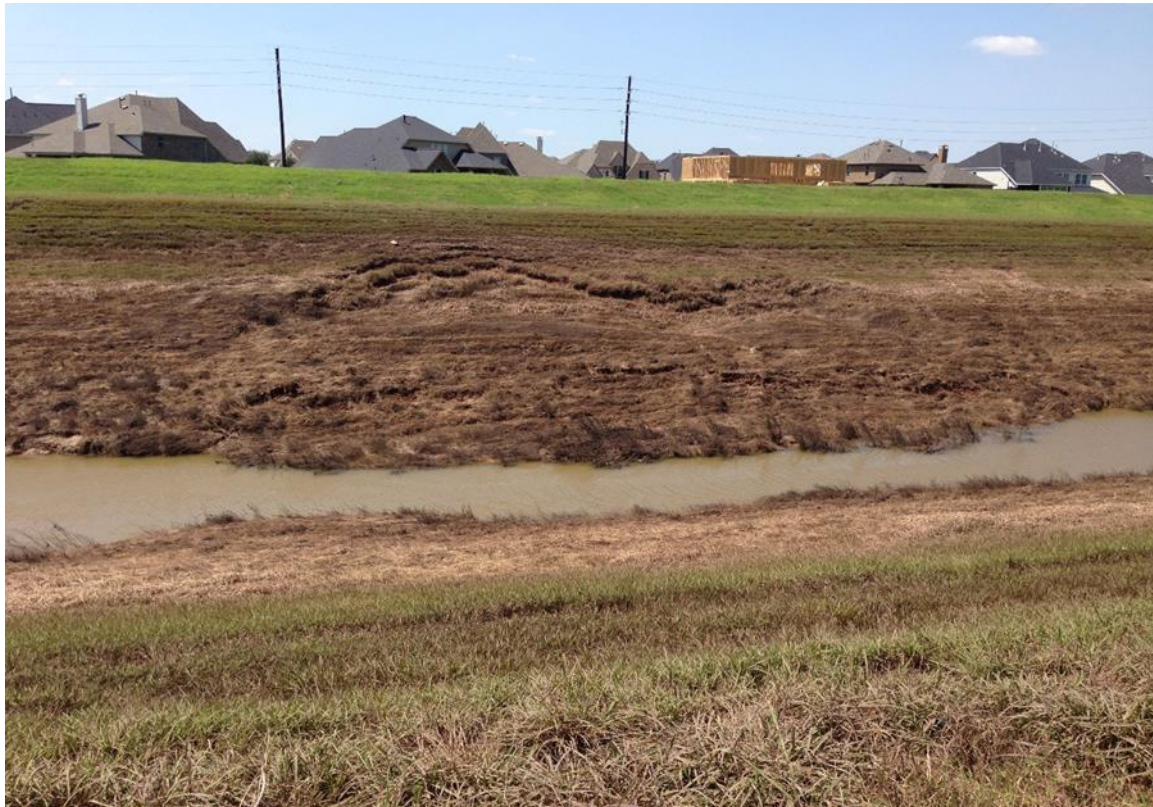
Figure 22. Earth slumping on the west side embankment (September 10, 2017, 29.53103° N, 95.56200° W).

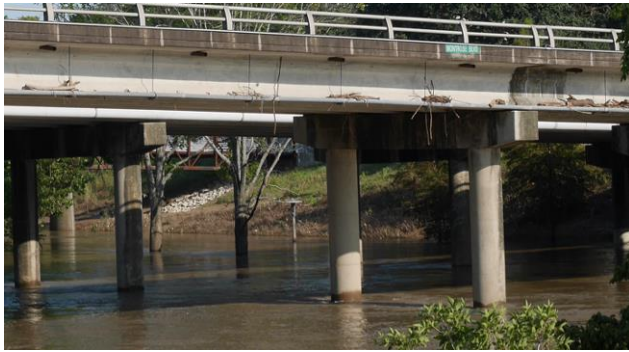
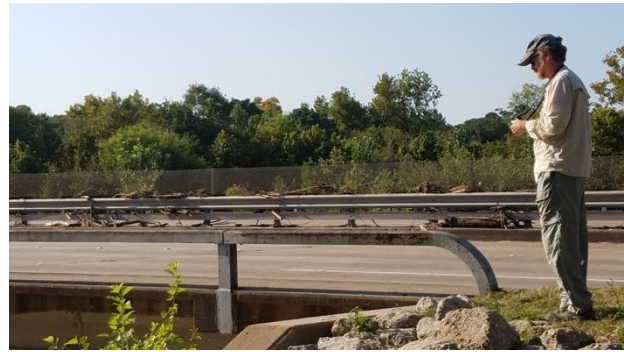
*Figure 24. Buffalo Bayou evidence of bridge overtopping (flood debris:) a) Montrose Bridge (September 9, 2017, 29.76307° N 95.39377° W), and b) Memorial Bridge (September 9, 2017, 29.76219° N 95.38425° W).*

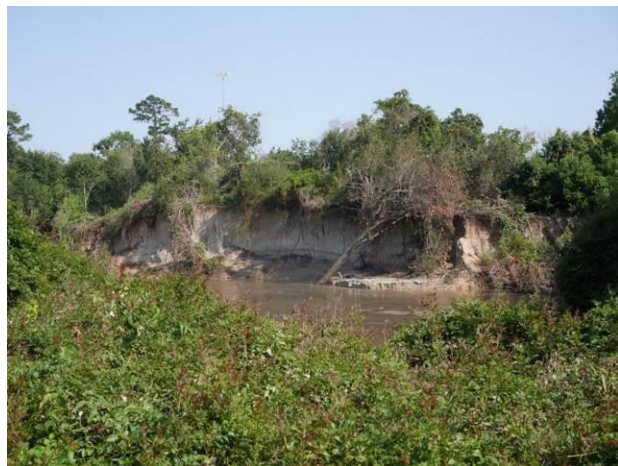
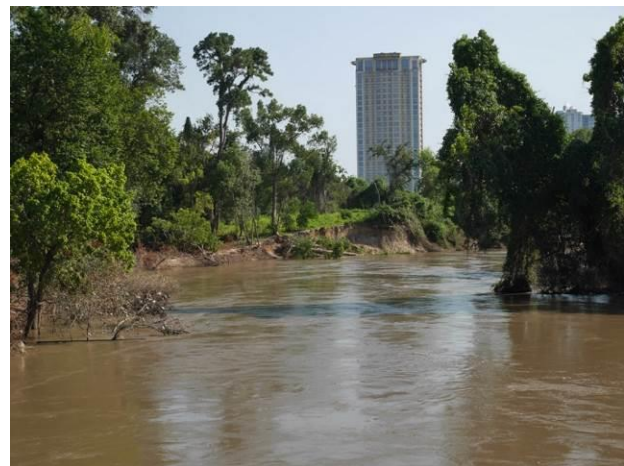
*Figure 26. Buffalo Bayous slope failures (September 9, 2017, 29.76318° N, 95.45945° W).*

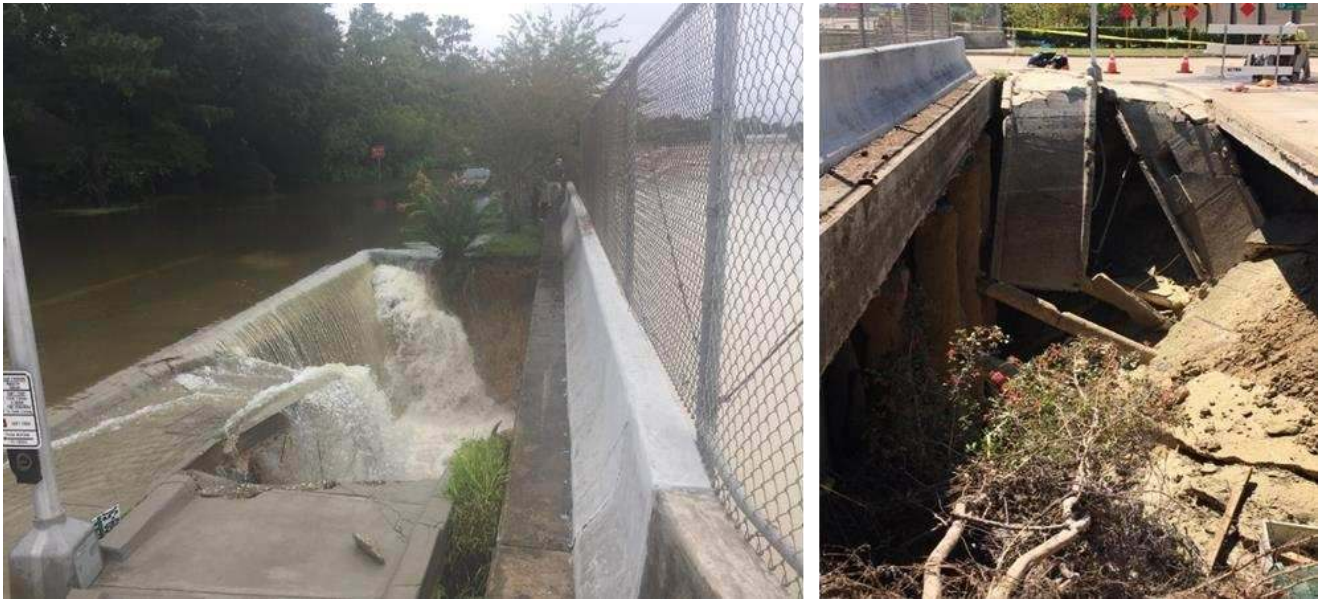
Figure 32. Damage of the walkway slab on Beltway 8 (left photo courtesy Brian Klein, a resident in the area, August 27, 2017, and right photo courtesy of a construction worker on site, 29.76735° N, 95.56219° W).

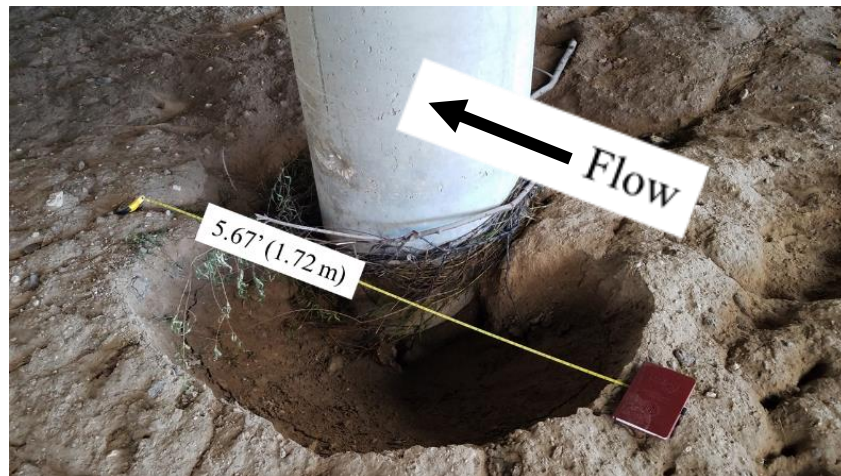
Figure 36. Bridge column scour (September 11, 2017, Time 10:06 CDT, 30.24688° N, 95.45796° W).

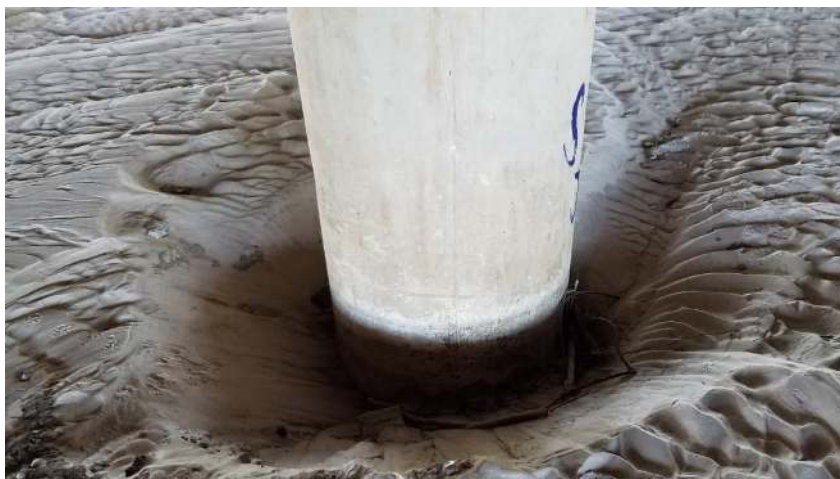
*Figure 40. Scour around columns on San Jacinto Banks (sandy soil). The scour hole was approximately 2.4 m (8 ft) across and 0.6 m (2 ft) deep (September 11, 2017, Time 10:59 CDT, 30.243364°N, 95.46452°W).*

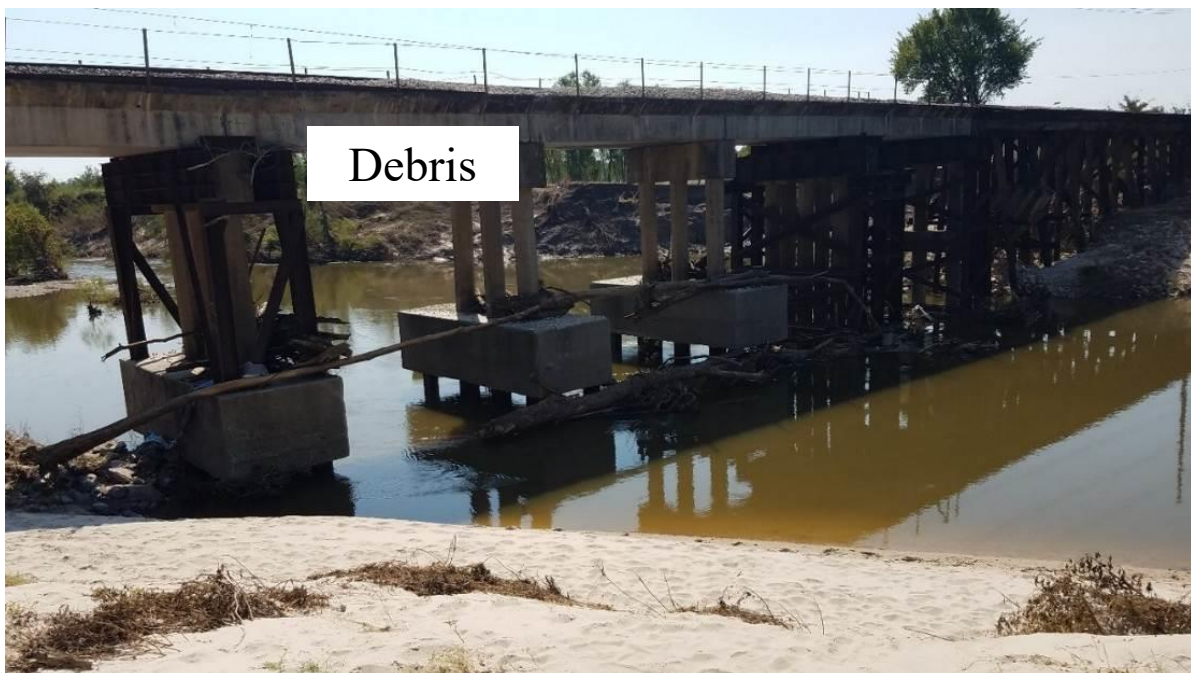
*Figure 42. Debris on railroad bridge indicating flow levels and scour around pile caps below current flow levels (September 11, 2017, Time 11:10 CDT, 30.24688° N, 95.45796° W).*

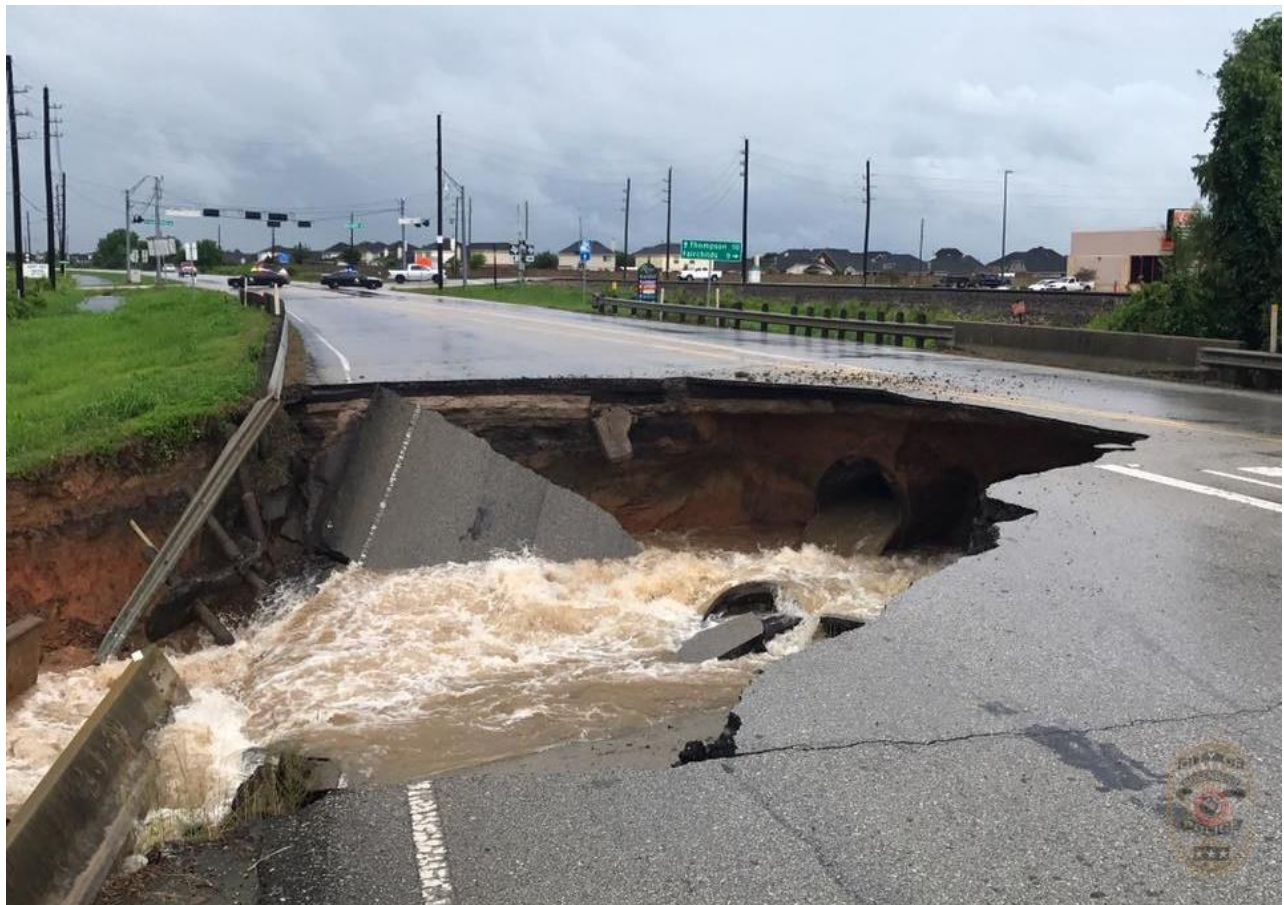
*Figure 43. FM 762 Washout on August 27, 2017  
(Courtesy of the Rosenberg Police Department, 29.5442° N, 95.7434° W).*

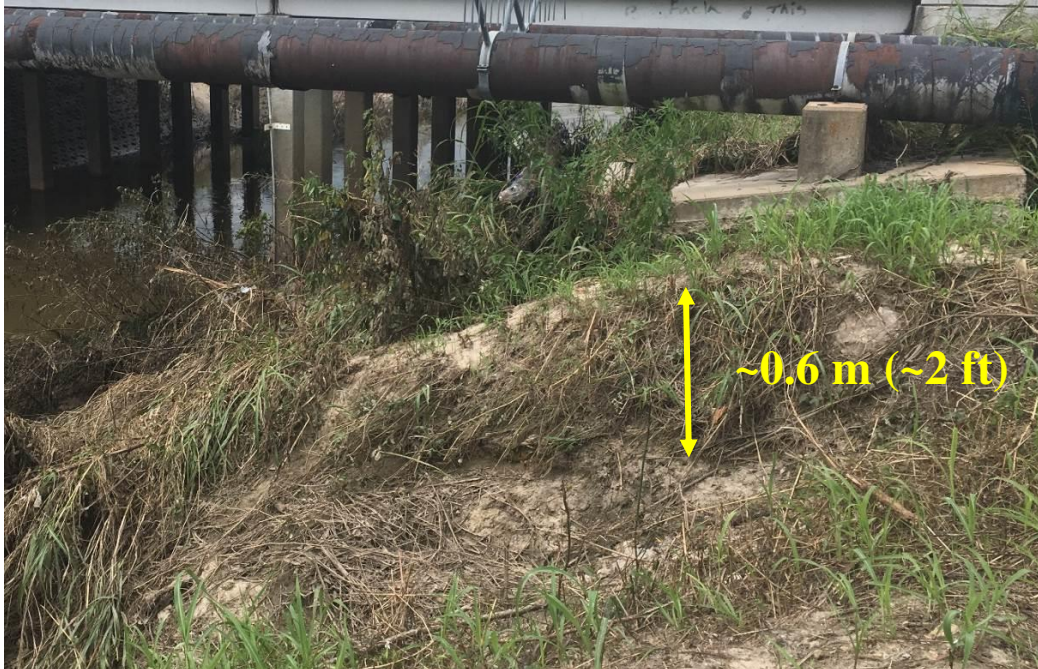
*Figure 44. Shallow soil failure along the north bank of Mustang Bayou, adjacent to pipe-support foundation (September 4, 2017, Time 12:48 CDT, 29.40889° N, 95.23234° W).*
