**Overcoming geological challenges in the  
construction of a CFSGD diversion tunnel**

A.A. Mert, M. Salman and F. Çalışkan

*General Directorate of State Hydraulic Works, Dams and HEPP Department, Ankara, Turkey*

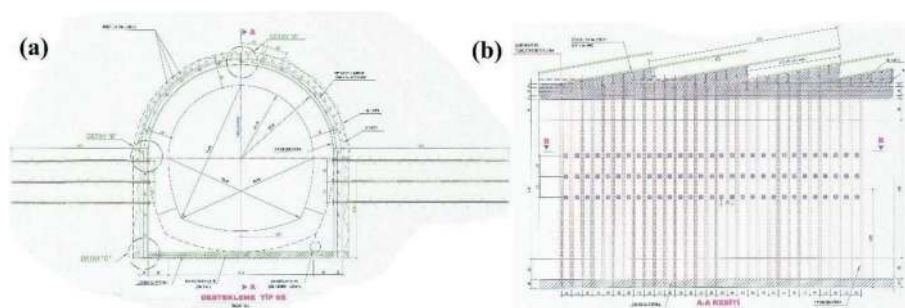
Figure 7. Detailed technical drawing of Type 6B umbrella-arch pre-support system: (a) Transverse cross-section illustrating the semi-circular pattern of the canopy and the specified IBO reinforcement zones; (b) Longitudinal profile (Section A-A) showing the overlapping pipe sequence, grouting intervals, and the spatial relationship between the pre-support and the tunnel face.

While steel canopy tubes are a standard NATM element, their application in the Kirik Dam diversion tunnel was necessitated by extreme geotechnical constraints that rendered standard spiling (Type 6A-2) ineffective. The primary innovation of the Type 6B system in this context was the integration of self-drilling IBO (Injectable Boreable) bolts with the umbrella arch to manage a rock mass that was essentially non-cohesive and water-sensitive.

In the Susuz Formation schists, drilled holes would collapse immediately, making the installation of conventional rock bolts impossible. The use of Ø32 IBO bolts allowed for simultaneous drilling and high-pressure grouting, ensuring that the reinforcement was fully bonded to the surrounding ground despite its poor quality. Furthermore, unlike standard passive spiling, the IBO bolts were actively tensioned to 2 tons using calibrated torque wrenches 18–24 hours after grouting, creating an immediate confined “reinforced ring” ahead of and around the face. This active, high-density reinforcement strategy (0.50m x 0.50m spacing) was the critical factor in arresting the progressive squeezing (NATM Class C2) that had previously caused deformations of up to 63 cm.

- An umbrella arch (forepoling) using 3.5" diameter, 9 m long pipes at a close 20 cm spacing over the upper 150° of the crown.
- Systematic L=6.00 m, Ø32 IBO (self-drilling) bolts, six per rib bay (3L+3R) at a dense 0.50 m × 0.50 m spacing.
- INP 200 steel ribs spaced at 0.50 m intervals.
- 30 cm of C20/25 shotcrete.
- Two layers of Q335×335 steel mesh.
- An invert arch to create a fully closed support ring.

The pre-support installation is conducted in a bay-by-bay manner, adhering to a strict procedural sequence. This sequence encompasses: (1) drilling and grouting of Injectable Borehole Anchors (IBOs), (2) installation of forepoles, (3) placement of steel ribs with an initial shotcrete and mesh layer, and (4) early closure of the invert. Following this, the IBOs are tightened to a calibrated torque. This entire process is managed by systematic convergence monitoring, which provides the data to inform adjustments in advance length and stand-time.

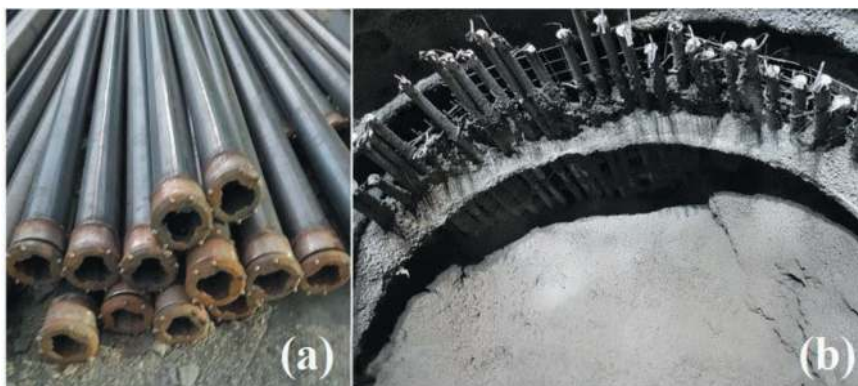
Figure 8. Type 6B support: (a) before; and (b) after application.

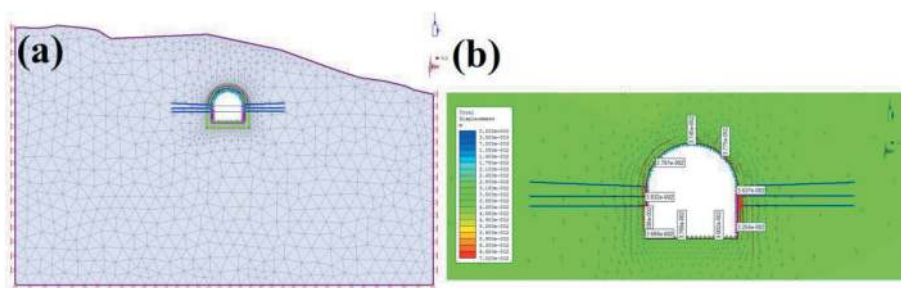
Numerical analysis of the Type 6B design confirmed its robustness. The maximum calculated force on the IBO bolts was 24.2 tons, which was safely within the 25-ton capacity of the bolts, indicating the system could withstand the high ground stresses. Figure 9 illustrates the computational framework used for these verifications, including the mesh configuration and the resulting vectorial distribution of ground movement.

Figure 9. Numerical analysis and resultant deformation patterns for Type 6B reinforcement: (a) Finite element mesh discretization and boundary conditions; (b) Results showing the distribution of total displacement vectors.

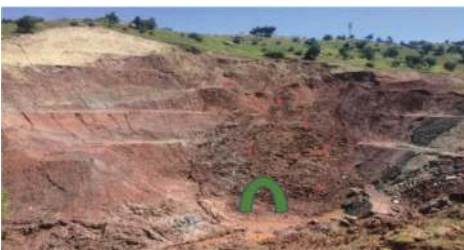
The excavations left exposed formed an altered zone in contact with air and water, lead a sliding, and the diversion tunnel exit was closed (Figure 3).

Figure 3. Diversion outlet, in-situ situation on 01.05.2020.

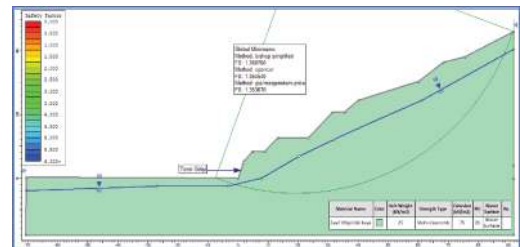
Figure 6. Diversion tunnel inlet 1H:1V supported static stability analysis (FS = 1.35 < 1.5).

It is recommended to apply steel mesh and at least 5cm+5cm shotcrete according to the support type in the project. In the final project, the bolt length is given as 4m, which is not long enough. In this type of soils, the bolts do not work because there is no block, solid rock where the rock bolt will be anchored and the slip surfaces are formed in a wide circle. Due to this reason, it is recommended to lower the slope gradients and reduce the bench heights in terms of stability. In cases where it is not possible to lower the slopes at the entrance section of the diversion (excavations enter into the body), the topography should be brought to its natural slope by passing through a conduit (such as a cut-and-cover tunnel) and backfilling.

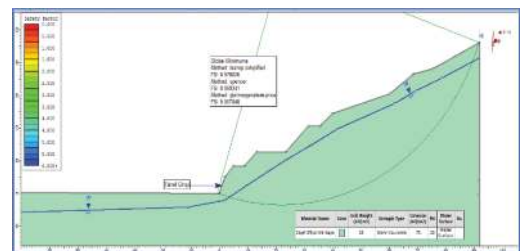
Figure 7. Diversion tunnel entrance 1H:1V supported seismic stability analysis (FS = 0.96 < 1.1).

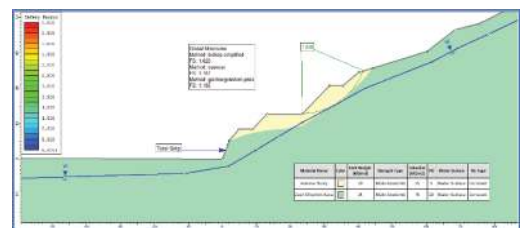
Figure 8. Diversion tunnel entrance 1H:1V unsupported static stability analysis (FS = 1.18 < 1.5).

If the slope is 3H:2V for permanent excavations, the slopes cannot be opened as they reach under the plinth and under the dam body. For this reason, since the portal excavations opened with temporary slope slopes of 1H:1V that do not provide stability, the slope stability will be ensured by constructing a conduit instead of a trapezoidal channel until the tunnel entrance and filling the slopes and conduit with fill and the topography reaching its own slope. Backfill slopes will not be steeper than 2H:1V. It is recommended that 1.00 m of rock fill should be placed on the backfill applied on the slope surface in order to prevent it from collapsing with the current.

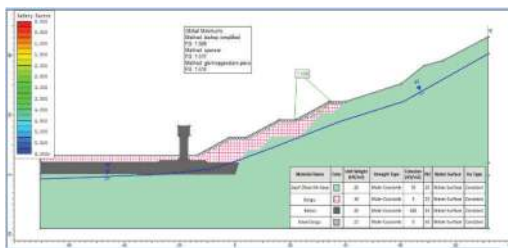
Figure 9. Diversion tunnel inlet conduit section static stability analysis (FS= 1.506 > 1.5).

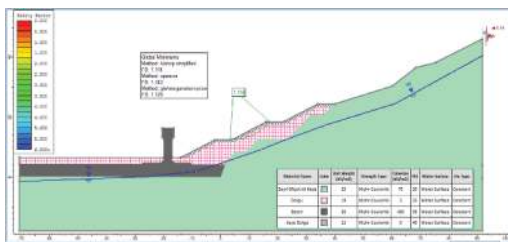
Figure 10. Seismic stability analysis of the diversion tunnel entrance conduit section (FS= 1.118 > 1.1).

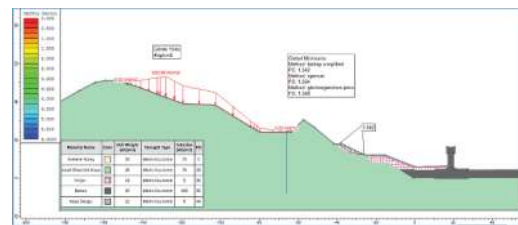
Figure 11. Interaction with the body after conduit backfill in static condition (FS=1.54>1.5).

Cleaning excavation will be made in the sliding area and it will be covered again with backfill after the conduit. It is recommended that the new slope excavations to be opened by the conduit should be opened with supports and drainage.

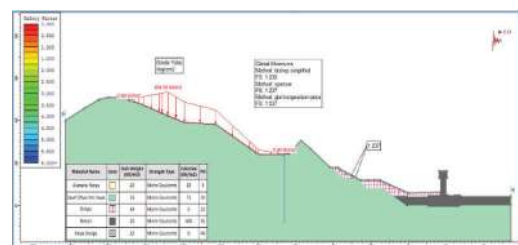
Figure 12. Interaction with the body after conduit backfill for seismic case (FS=1.23>1.1).

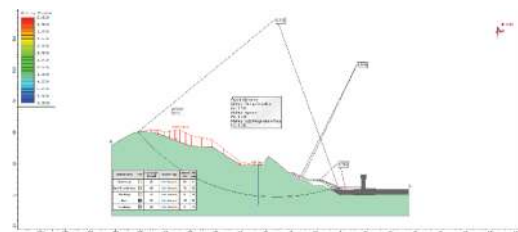
The analysis below corresponds to the model in Figure 12, utilizing an actual PGA of 0.48g from the M7.8 magnitude earthquake as the horizontal ground acceleration. Factors of safety below 0.759 are associated with shallow slope failures, and only critical and deep slope surfaces were evaluated, ensuring a minimum factor of safety of 0.759.

Figure 13. Interaction with the body after conduit backfill for seismic case for 0.48g (FS=0.759<1.0).

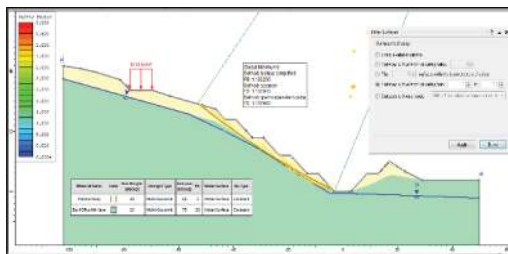
In the analysis performed without support in temporary excavation at the critical section of the diversion outlet, the safety factor was 1.18 due to the effect of the altered zone. As also seen in the field, failures occur from the slope surface (Figure 14).

Figure 14. Diversion outlet 1H:1V unsupported static stability analysis (FS=1.18<1.50).

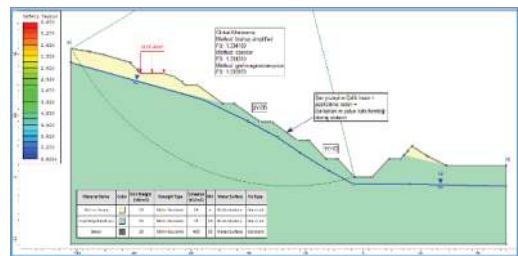
Since the safety factor is 1.33 for the first two slope surfaces 1H:1V from the base and 3H:2V for the upper slopes, there will be a stability problem in case of permanent excavation (Figure 15).

Figure 15. Static stability analysis with diversion outlet 1H:1V support (FS = 1.33 < 1.50).

The diversion outlet's critical section underwent analysis with slope reinforcement, utilizing steel mesh and shotcrete during excavations on a 1H:1V slope to obstruct the unit's contact with air and water. It is anticipated that cutting this contact, along with water removal through a drainage system, including head ditches and weep holes in the benches, will prevent the formation of an altered zone. Application of steel mesh, 5cm+5cm shotcrete, and weep holes in the supports was considered. Analysis revealed that the use of short rock bolts did not significantly impact stability, given the wide sliding arc.

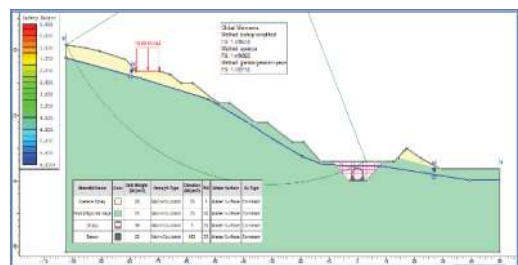
If filling is done only up to the first bench, stability problems will still persist (Figure 16).

Figure 16. Static stability analysis of backfill up to the first bench at the diversion outlet (FS = 1.41 < 1.50).

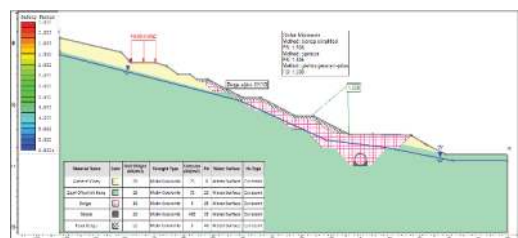
Figure 17. Static stability analysis of embankment up to the first two benches of the diversion outlet (FS = 1.508 > 1.50).

Stability problems will be eliminated if the first two benches are backfilled. The topography approximately reaches its natural slope. Embankments are analyzed as 2H:1V. Embankments should not be constructed at steeper slopes.

The slope heel filling on the slope close to the natural slope of the topography was analyzed below. The case of filling with backfill up to the first two bench elevations and supporting the slope surfaces with 2H:1V slope protection embankment is analyzed. In the slope protection embankment, it is recommended to construct a slope protection cover with 1.00m rock fill against surface runoff.

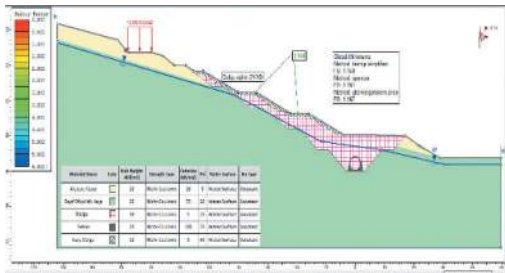
Figure 18. Seismic condition stability analysis of the embankment up to the first two benches of the diversion outlet (FS = 1.14 > 1.1).

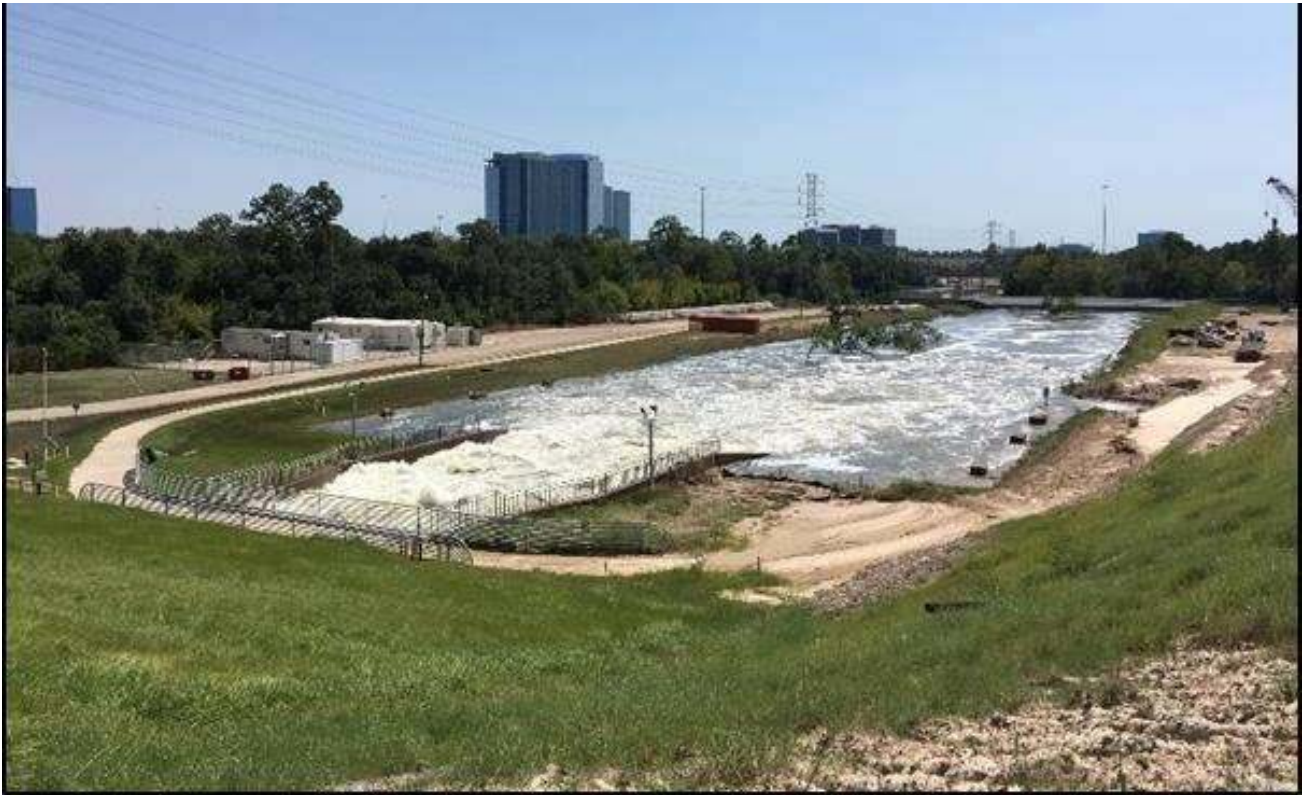
Although hydrologic/hydraulic performance of the dams was outside of our purpose and primary expertise, it appeared that Addicks and Barker Dams fulfilled their mission of reducing the impact of flooding for a significant part of the Houston area, specifically along Buffalo Bayou downstream of the dams, including the central business district. During the heaviest rainfall, around 86-89 cm (34-35 inches) of rainfall was recorded in the watershed. Peak reservoir levels occurred on about August 30, 2017 at 33.3 m (109.1 ft) and 31.0 m (101.6 ft) in the Addicks and Barker reservoirs, respectively. The highest elevations of the crest for these two dams are 34.1m (121 ft) and 34.1 m (112 ft), respectively, which provided freeboards of approximately 3.4 m (11 ft) (Addicks) and 3.0 m (10 ft) (Barker) at the peak reservoir levels. The peak reservoir water level in Addicks slightly exceeded the level of the ground at the north end of Addicks north auxiliary spillway (details below). The USACE opened the Addicks outflow gates on August 28, 2017 to reduce risks associated with higher water levels. These outflows peaked around August 30, 2017 at about 200 cubic meters/second ( $\text{m}^3/\text{s}$ ) (7,000 cubic ft per second [cfs]) for Addicks and 180  $\text{m}^3/\text{s}$  (6,300 cfs) for Barker. The USACE noted that Addicks and Barker Dams reduced peak flows in Buffalo Bayou by more than 3,540  $\text{m}^3/\text{s}$  (125,000 cfs) during the April 2016 flooding, a smaller event than Hurricane Harvey. The April 2016 event, also known as the Tax Day Flood, resulted from about 43 cm (17 inches) of rain, which accumulated over just 12 hours and caused the previous record pools for the dams. During the time of our visit on September 9, 2017, the gates of the dams were opened to allow flows of 170  $\text{m}^3/\text{s}$  (6,000 cfs) (Addicks) and 110  $\text{m}^3/\text{s}$  (4,000 cfs) (Barker) for a total flow into the Buffalo Bayou of 280  $\text{m}^3/\text{s}$  (10,000 cfs) (see Figs. 5 and 6). The USACE gradually reduced outflows from these levels to a total of 110  $\text{m}^3/\text{s}$  (4,000 cfs) on September 17, 2017.

*Figure 5. Addicks outlet releasing  $\sim 170 \text{ m}^3/\text{s}$  ( $\sim 6000 \text{ cfs}$ ) (September 9, 2017,  $29.79026^\circ \text{ N}$ ,  $95.62378^\circ \text{ W}$ ).*

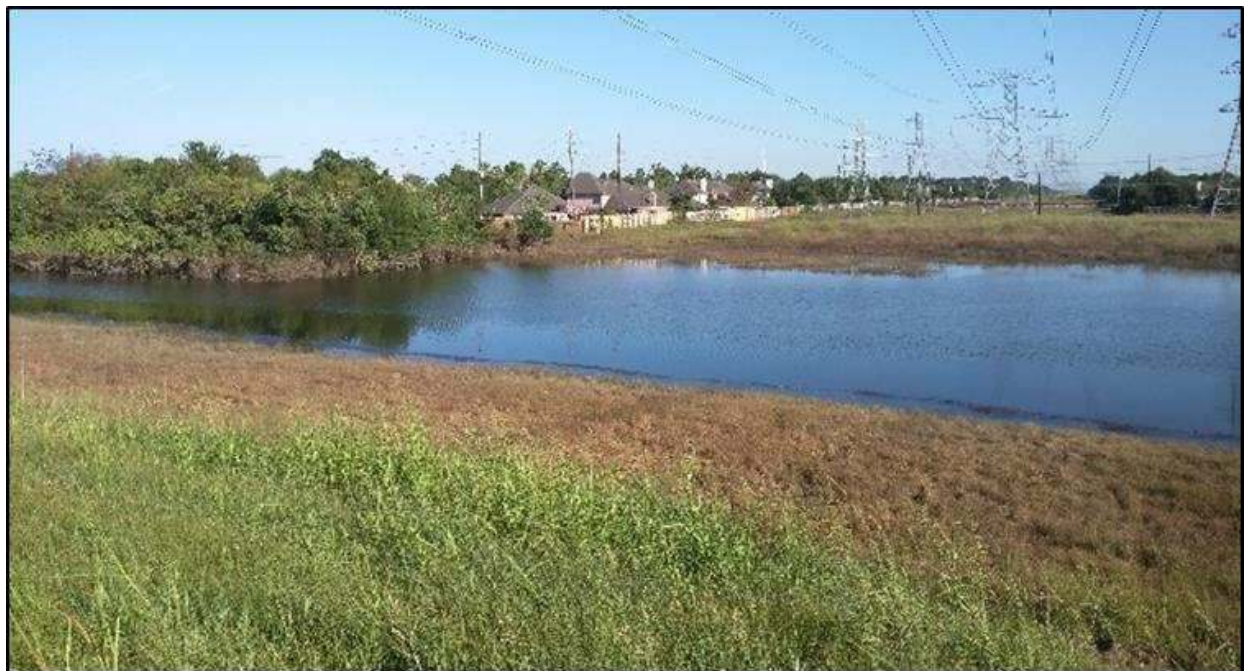
The high-water levels in the Addicks (El. 33.3 m [El. 109.1 ft]) and Barker (El. 31.0 m [El. 101.6 ft]) Reservoirs exceeded not only the April 2016 historic high levels (El. 31.3 m [102.7 ft] at Addicks and El. 29.0 m [95.24 ft] at Barker) but also the elevations at the upstream edge of the USACE property. As noted previously, housing developments extended up to these boundaries and, consequently, were flooded during Harvey (see Figs. 9, 10, and 11). Area subsidence likely contributed to

*Figure 10. Flooded residential area in the southwest corner of the Barker Dam (September 9, 2017, 29.70706° N, 95.72835° W).*

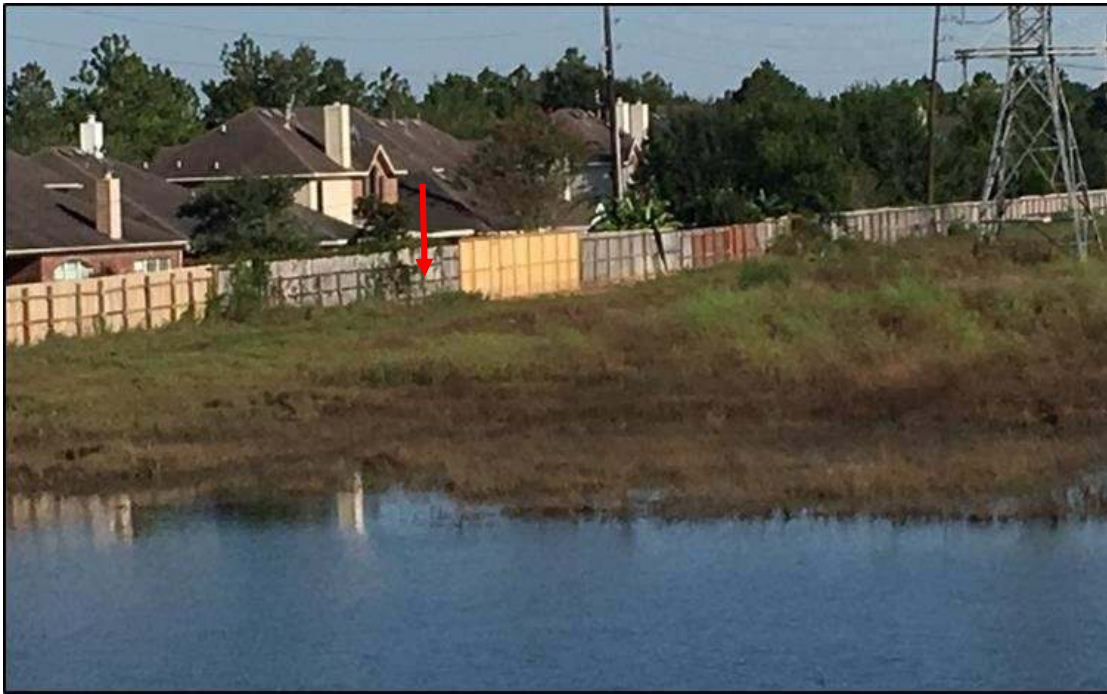
*Figure 11. High water mark on fences surrounding residential area (September 9, 2017, 29.70706° N, 95.72835° W).*

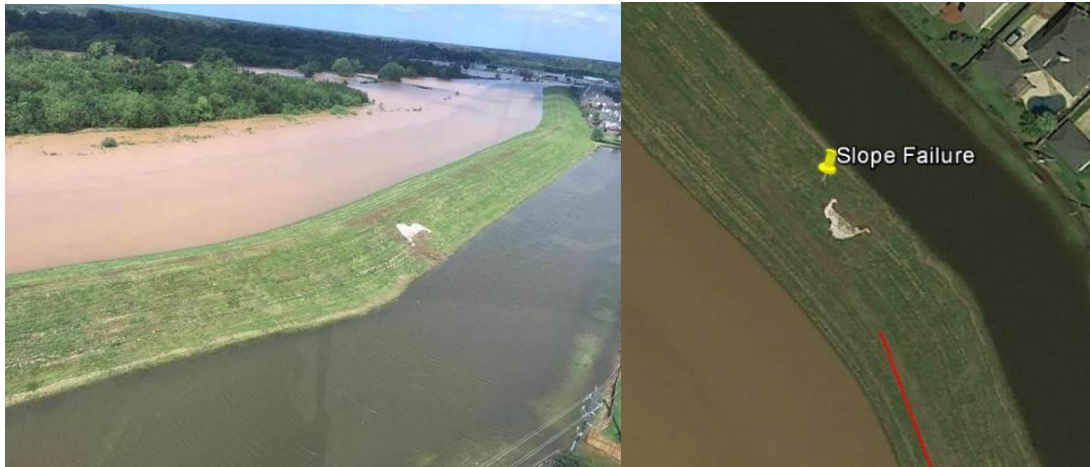
Overall, we understand that the Brazos River LID levees performed well, with no major failures, breaches, or overtopping. One incident of a surficial slide on the protected slope of a Sienna Plantation LID levee was reported and photographed by others as shown in Fig. 14 (see Location 2 on Fig. 13). The GEER team visited the First Colony LID 2 (see Location 3 on Fig. 13) and two of the drainage ditches that serve the LIDs (see Locations 4 and 5 on Fig. 13). Despite the good levee performance, flooding occurred within several LIDs due to the issues with storm water removal from the protected side behind the levees to the river side. Some LIDs were even completely cut off due to water surrounding the entirety of the LID.

Figure 14. Aerial photo (right) and Google Earth (left), August 30, 2017, 29.491844° N, 95.541017° W.

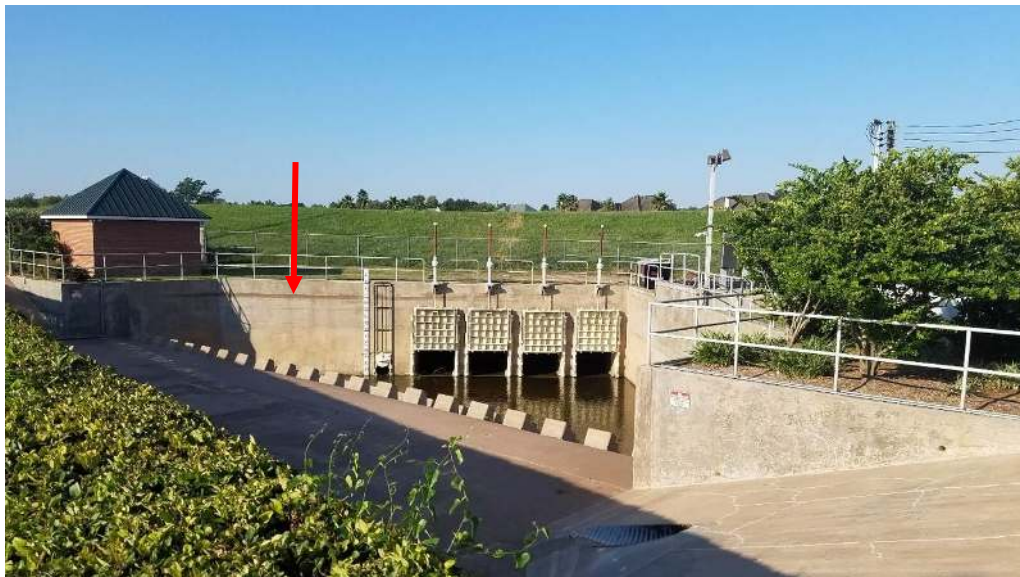
The levee system in FCLID2 was built in 1988, protects 1,200 homes, which are collectively valued at \$430,000,000, and performed well during the Hurricane Harvey event. Major elements of the system include the levees, a pump station with two 83-cubic-meter/minute (22,000-gallon/minute) pumps, a diesel generator for emergency power, and a flood gate structure with two 91-cm (36-inch) discharge outfalls and four 183-cm (72-inch) flood gates. During the event, an emergency pump was brought on site for backup. Due to the record rise of the Brazos River, both pump outlets were discharging under several feet of water but were able to keep up with internal stormwater accumulation. The water height on the river side reached a surveyed maximum elevation of 21.6 m (70.8 ft) along the FCLID2 levee. The levee crest at FCLID2, at elevation 23.8 m (78.1 ft), provided a freeboard of 2.2 m (7.3 ft). The high-water level within the pump station basin on the protected side of the levee is visible in Fig. 15 at about El. 19.8 m (65 ft) on the gauge. Fig. 16 shows the condition of the levee and drainage ditch that conveys water from the protected side of FCLID2 out to the Brazos River. The FCLID2 monitored the levee and pump station system 24 hours a day during the hurricane and high-water levels of the Brazos River. Routine levee maintenance by the FCLID2 included keeping a dense grass cover that is long enough to ensure solid root structures, irrigation for the grass cover and to prevent levee desiccation cracking, and repair of damage caused by rooting and burrowing animals. In FCLID2, wild hogs and fire ants are the main burrowing animal concerns.

Figure 15. FCLID2 drainage outfall / pumping station basin, showing four 1.4 m (60 inch) flood gates, high water line at ~19.8 m (65 ft) gauge height, levee in background (September 10, 2017, 29.55509° N, 95.61779° W).

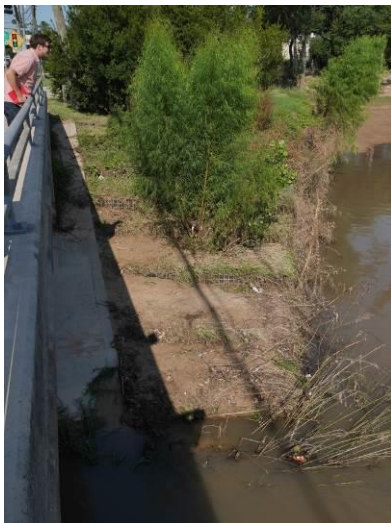
Upon arrival of the GEER team at sites along Buffalo Bayou on September 9, 2017, the observed flows in the bayou were about  $210 \text{ m}^3/\text{s}$  (7,300 cfs) at the USGS Addicks gauge. Flooding of residential areas had been largely reduced by September 9, though much of the former parks and trails along the bayou were still inundated with water. Signs of the previous flooding could be seen with river debris noted on bridge girder and railings (see Fig. 24). No critical geotechnical failures were noted along the observed portions of Buffalo Bayou, but scour areas and a slope failure were observed (see Figs. 25 and 26).

*Figure 25. Buffalo Bayou evidence of scour a) Bridge abutment, and b) Downstream of Woodway Drive Bridge (September 9, 2017, 29.76457° N 95.45815° W).*

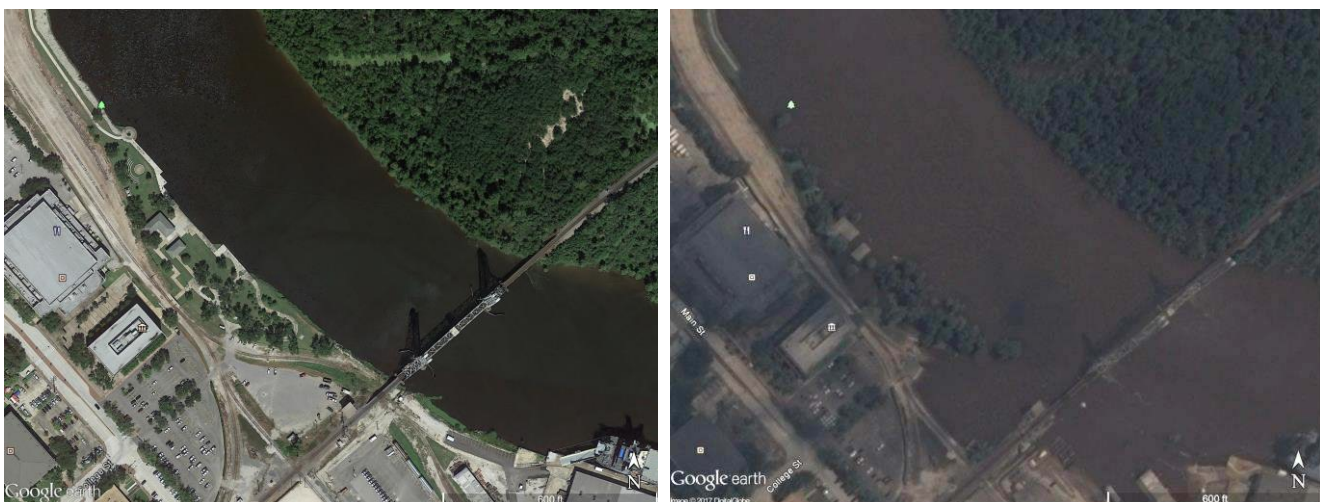
Figure 28. Aerial images of Beaumont Riverfront Park, January 2015 (left) and September 3, 2017 (right) (Google Earth).

Figs. 29 and 30 show the loss of shoreline and scarps left by the Neches River erosion of the park shoreline, starting from an upstream section protected by riprap and extending through the downriver port area. The pre-hurricane park area shoreline was fronted with a riverwalk/dock (see aerial on Fig. 28), which was largely washed out. Based on pre-hurricane aerials on Google Earth, the shoreline had eroded up to about 15 m (50 ft) from the previous shoreline.

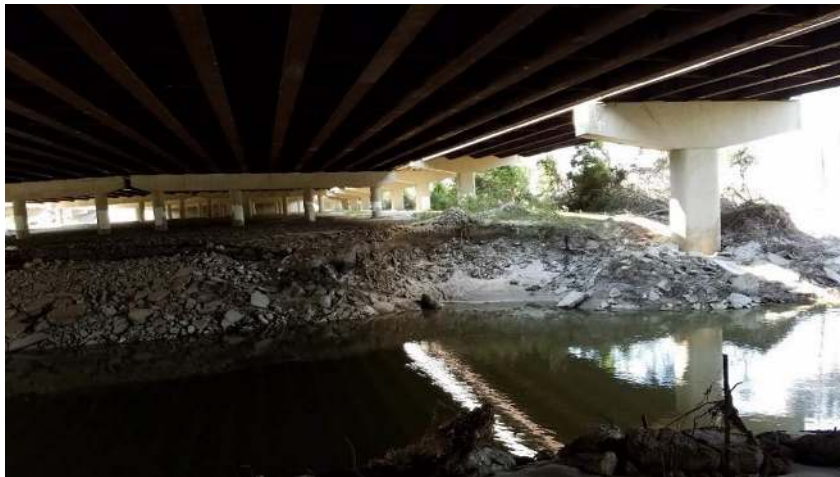
As expected, bridge columns with no erosion control had variable amounts of accumulated debris (see Fig. 35) and scour (see Figs. 36 & 37). No measurable scour was observed around columns with erosion control (see Fig. 38), which included riprap and polymeric reinforcement. Fig. 40 shows the bank of the San Jacinto River from the north side, facing south. The riprap along the banks likely reduced the erosion of the fine, sandy soil. Fig. 41 shows an observed 2.4-m- (8-ft-) diameter scour hole in the sandy bank material. Despite the observed scour, no geotechnical or structural failures were observed on the I-45 Bridge over the San Jacinto River.

*Figure 39. Riprap along south bank of San Jacinto River (September 11, 2017, Time 10:56 CDT, 30.24574° N, 95.45761° W).*
